Property Inspection Report

Report Number: 10106

401 Buyme Lane
Observation, NC 27513

Date of Inspection: Thursday, February 13, 2020

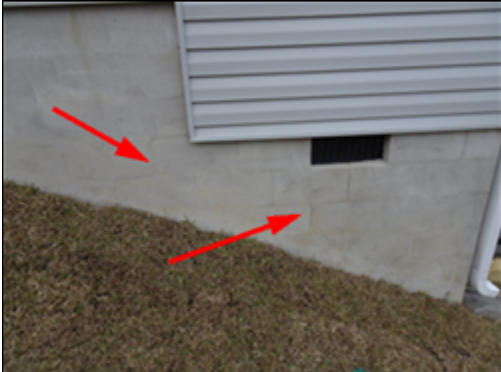
(A1 - 1.1) Main House

Closed/Open cracks were noted in the foundation of the home. Cracks in the foundation indicate a deficiency in the foundation, footing, or supporting soil that can change and worsen if it progresses over the life of the home. An engineer should be consulted to determine the significance/cause of the cracks and outline any necessary repairs.

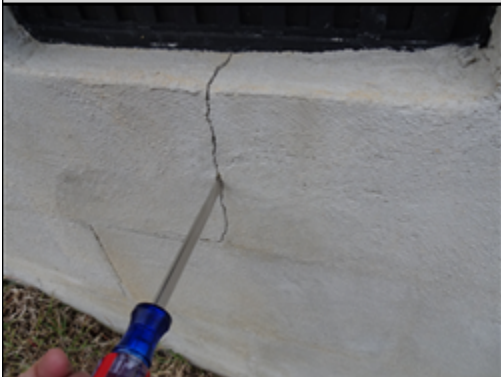
(A1 - 1.2) Main House

Additional Photograph: This is a photograph of the crack closest to the back right corner. This is larger than what is common for a new home. The steep hill makes the crack more of a concern needing evaluation. An engineer should be consulted for a complete evaluation, to determine the significance of the concern and outline necessary repairs.

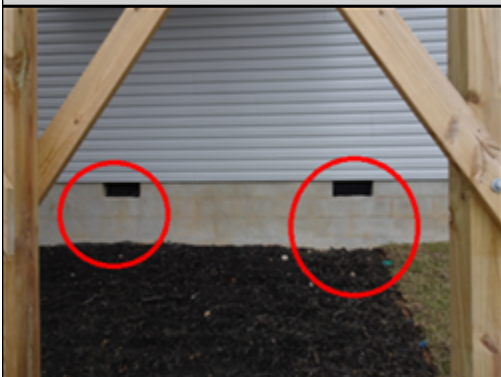
(A1 - 1.3) Main House

More cracks on the back.

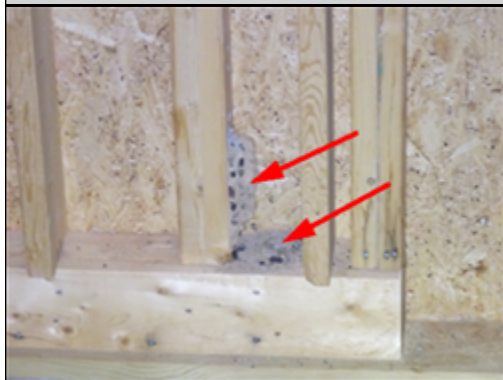
Mud dobber removal is needed in the crawl space.

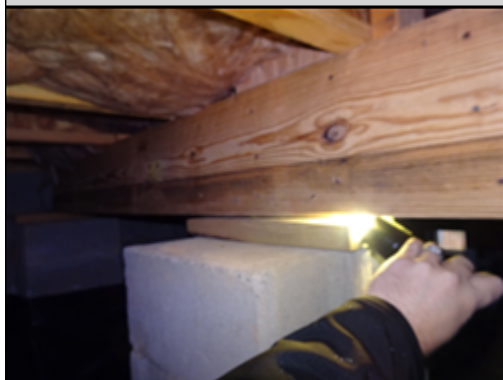
The load of the structure is carried down to the foundation through the floor system. This area under the foyer has a gap which will cause the structure above to sag resulting in drywall pops or more significant concerns. A general repair person or general contractor should be consulted for the repair.

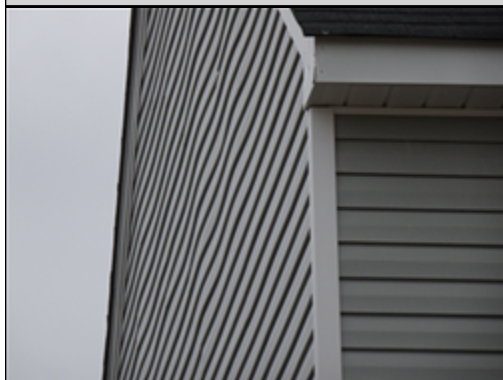
The walls in the attic on both sides of the home are not flat. A licensed general contractor should be consulted for further evaluation and to make necessary repairs.

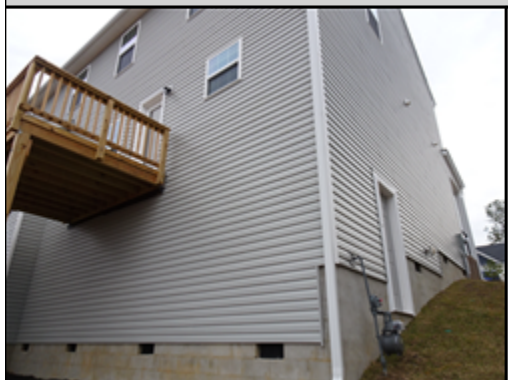
The siding was noted to be installed tightly without leaving room for expansion during summer months. Without proper expansion and contraction clearances the siding may buckle or become loose. A siding installation company or general contractor should be consulted to evaluate and repair the siding to ensure the integrity of the cladding system.

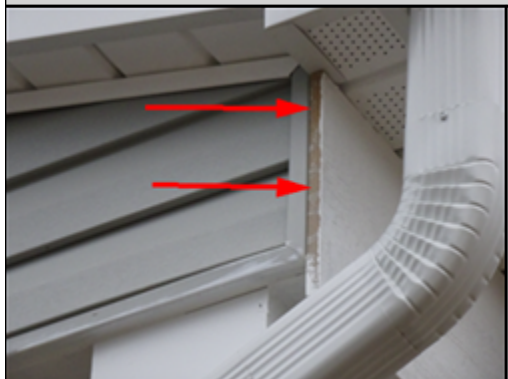
The trim on the front left is not painted. A licensed general contractor should be consulted for a full evaluation of the entire system and repair.

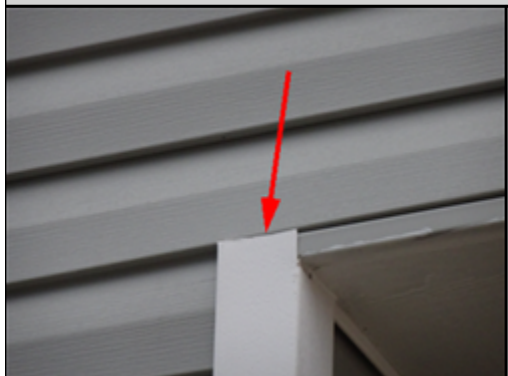
The siding is not flashed on the front left. This should be repaired or replaced by a general contractor to prevent damage from water entry into the wall. Future hidden damage is possible.

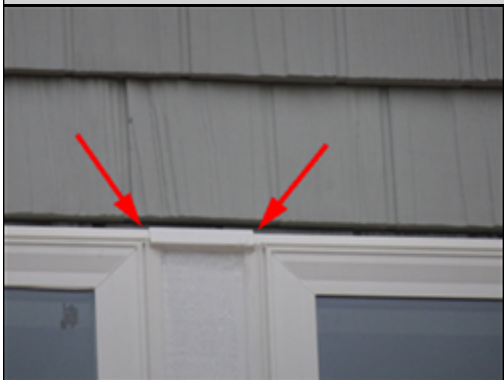
Typically, the mullen for the windows by the master bedroom has a J-channel that runs across both windows in one piece to avoid leaks. The areas by the arrows may allow water down the mullen and cause decay. Builder evaluation is needed.

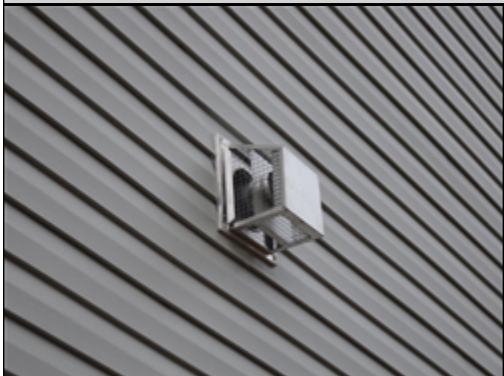
The trim is not properly installed by the exhaust. There is no flashing/J-channel and no flat trim panel which diverts water away from the home and down the siding. The caulk used here is not designed to be installed this thick and is not designed to hold the vinyl siding (when applicable) in place. This should be repaired or replaced by a general contractor to prevent damage from water entry into the wall. Hidden damage is possible.

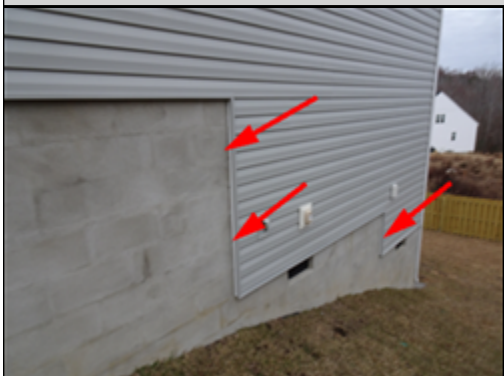
The siding is not covering the wall structure. This should be repaired or replaced by a general contractor to prevent damage from water entry into the wall. Future hidden damage is possible.

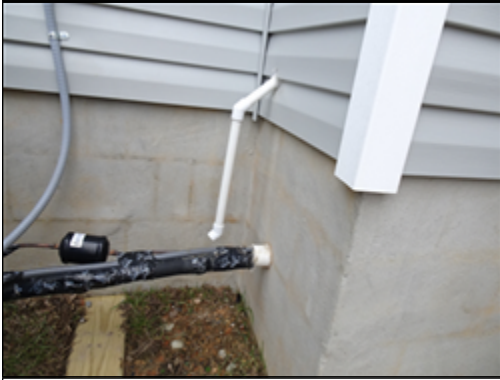
The condensate drain is too close to the foundation. The building code does not require this extension but water does often seep through the foundation from here. This can cause the soil to stay wet when the surrounding soil is dry. This wet soil expands causing a strain on the foundation system which can lead to cracking. High Efficiency Furnace drains must be properly extended in a manner that will not freeze in the winter. A licensed HVAC Contractor should be consulted to extend this tubing to a proper design and length.

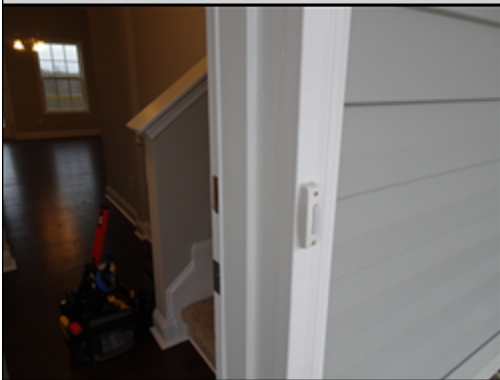
(B3 - 1.1) Porch

The doorbell as tested from the main entrance and found not to be functional. A general repair specialist should be consulted for evaluation and repair.

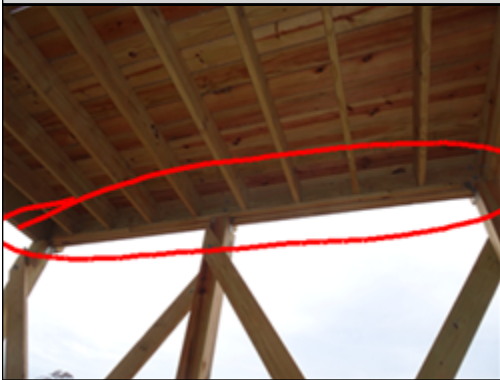
The joist have only been nailed from the exterior band. Nails that follow the grain of the joist is the weakest nail connection between framing members. The floor joist should have toe nailing added for structural integrity. Improper deck construction can result in unsafe conditions and possible deck failure. A licensed general contractor should be consulted for a complete evaluation of the deck and to make necessary repairs.

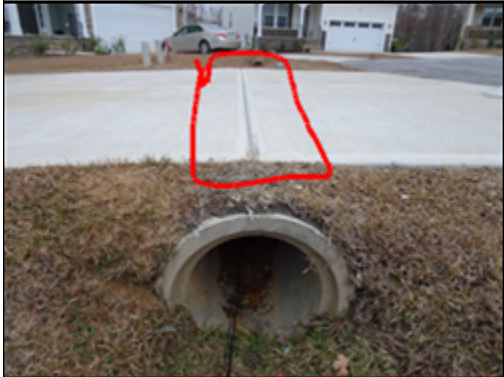
The driveway is thinner than the typical 4 inches and is much more likely to crack in this area. The round culvert does not offer even support for the slab. A licensed general contractor should be consulted for further evaluation, to determine the extent of the damage, and to make necessary repairs.

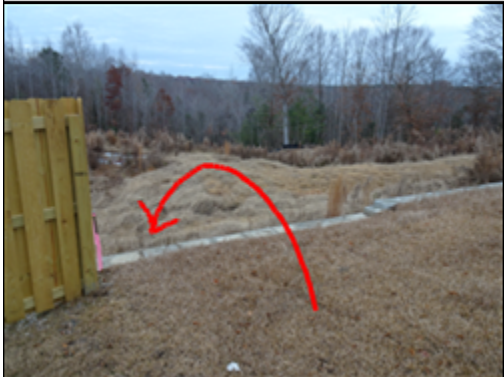
On the back side of the neighboring home, the lot elevation changes. The soil between the levels is retained by a brick retaining wall. There is no guard rail along the wall to prevent a person or animal from falling from the higher front grade to the lower basement level. The absence of a safety railing for a wall of this height presents a safety hazard. A licensed general contractor should be consulted for further evaluation and repair.

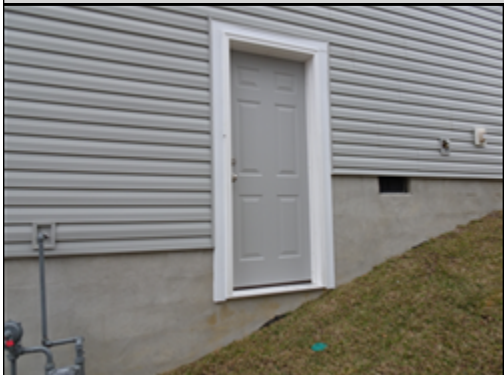
Having no step near the crawl space door is a fall hazard. A licensed general contractor with experience in landscaping and grading should be consulted to evaluate and correct the grading as needed.

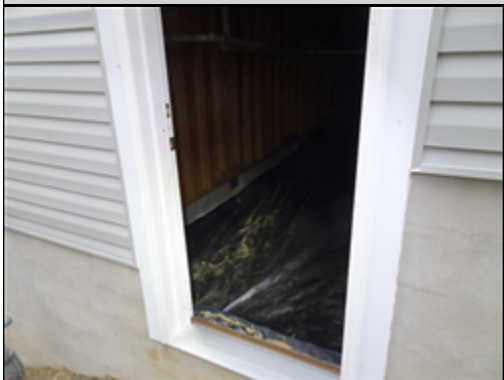
The same applies when one enters the crawl space, the plastic makes the slope even more dangerous.

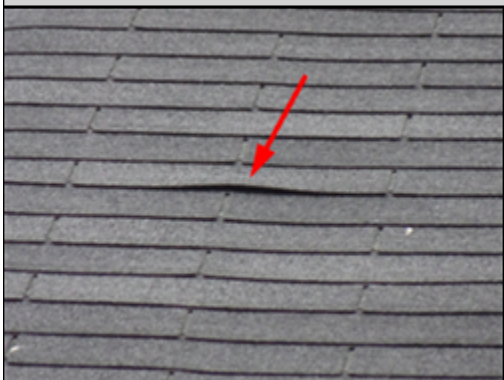
Bumps in the shingles like this on the front are often caused from nails working loose on an older roof which is a sign of age. On a newer roof this is likely to be from a bent nail from installation. Stepping on these area will damage the shingles and these area can leak regardless. Also, these shingles will be the ones that catch the wind and will be the more likely to blow off. A licensed roofing contractor should be consulted for the complete evaluation and repair to the roof covering system.

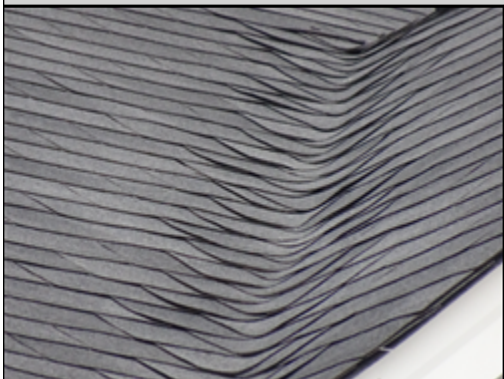
The valleys are woven in a way that runs up the valley more than what is common and is more prone to leak. Also, the shingles that do not lay flat are more likely to blow off, tear etc. A roofing contractor should be consulted for a complete evaluation of the roof covering and flashings system to make necessary repairs to ensure the weathertightness of the roof covering system.

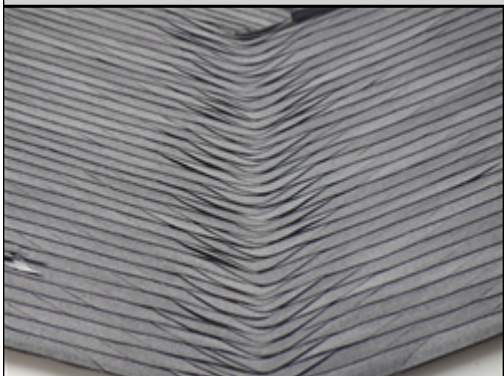
Note - this applies to all valleys along the front of the home.

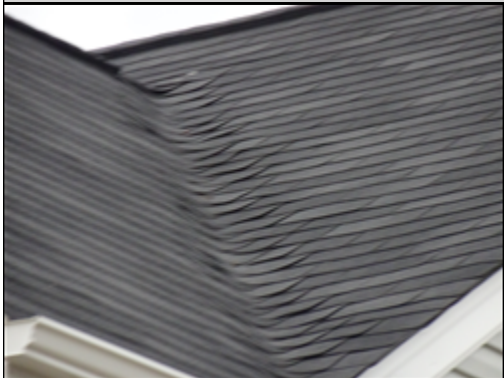
Note - this applies to all valleys along the front of the home.

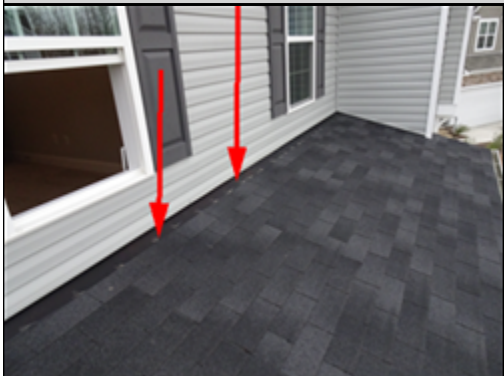
There is no path for ventilation between the lower and upper attic spaces over the front porch. Improper attic ventilation can damage building component such as heat damage to the shingles, void shingle warranty, and result in inadequate conditioning of the living areas when applicable. A licensed general contractor should be consulted for repair/ replacement.

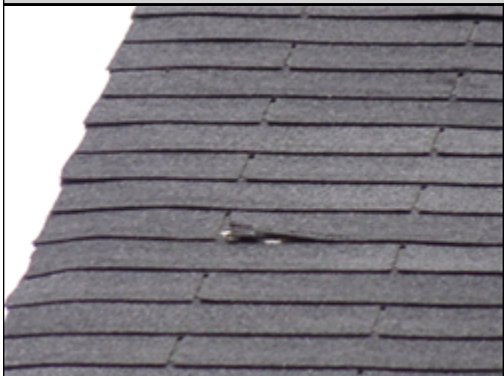
The shingles have been damaged from foot traffic/ladders/tools and are in need of replacement like this on the front left. The number of damaged shingles were too many to give specific locations. Damage to the ballast (small rocks) removes the layer that protects the water proof layer underneath. This will result in premature failure of the damaged shingles. A licensed roofing contractor should be consulted for a full roof evaluation of the entire roof covering system.

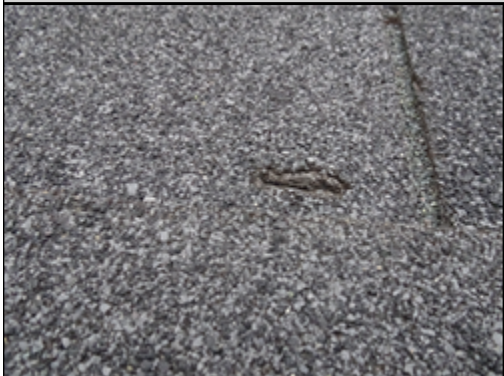
More damage was found over the porch.

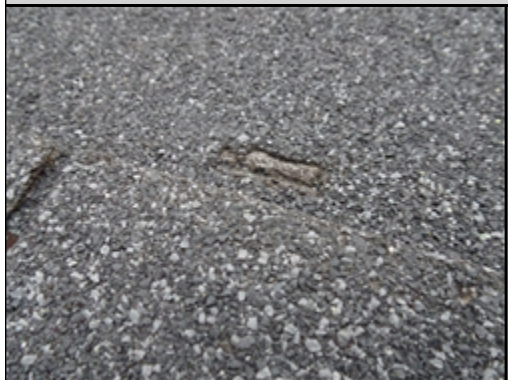
More damage was found over the porch.

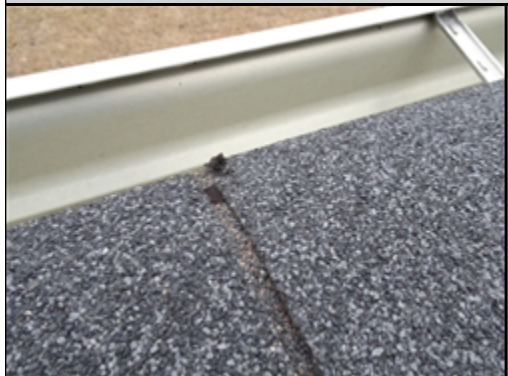
More damage was found over the porch.

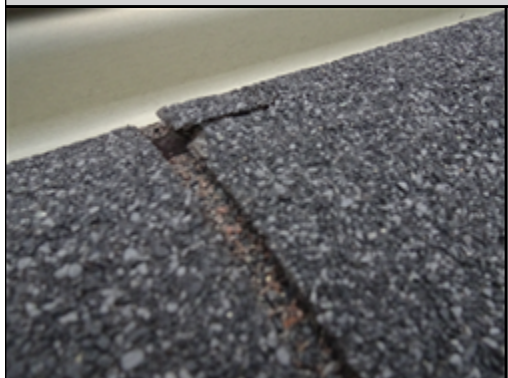
More damage was found over the porch.

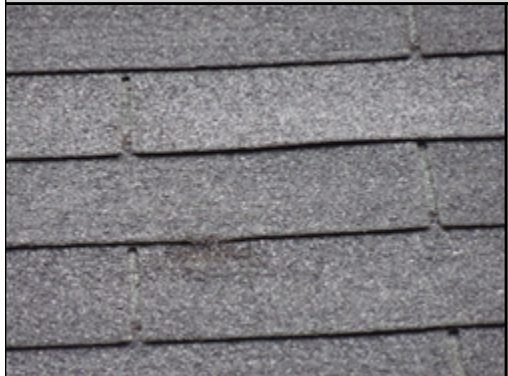
More damage was found over the upper front part of the roof.

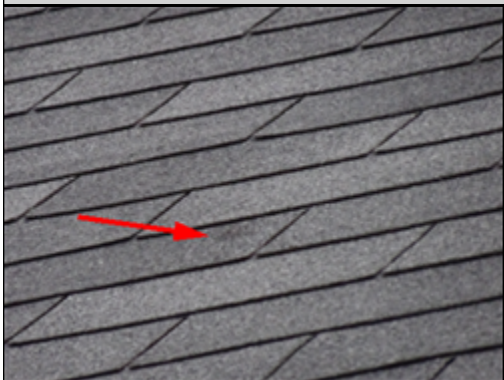
More damage was found over the upper front part of the roof.

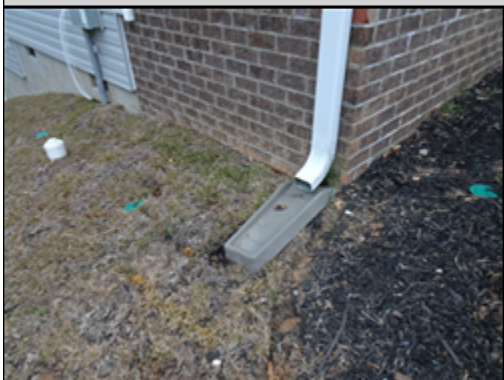
The gutter downspouts are not all effectively extended or piped to direct roof drainage away from the foundation. Direct drainage from the gutter system can result in direct water penetration into the foundation area and foundation deterioration. A licensed general contractor should be consulted for a complete evaluation and to make necessary repairs.

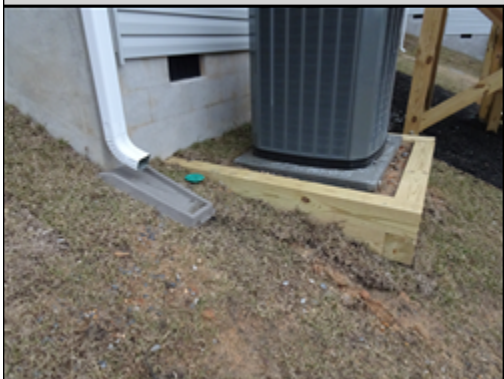
All downspouts should be extended, this one will erode the HVAC retaining wall which will damage the unit.

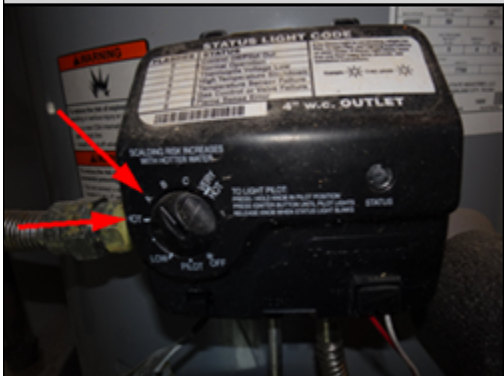
The hot water temperature for the home was noted to be too high. This may be a malfunction because the water heater is set close to the proper setting. The recommended temperature to prevent personal injury and burns is 120 degrees F. The elevated temperature could indicate a malfunction or problems with the water heating unit. A licensed plumbing contractor should be consulted to evaluate the system to ensure that the water heating unit is operating correctly and within a safe temperature range.

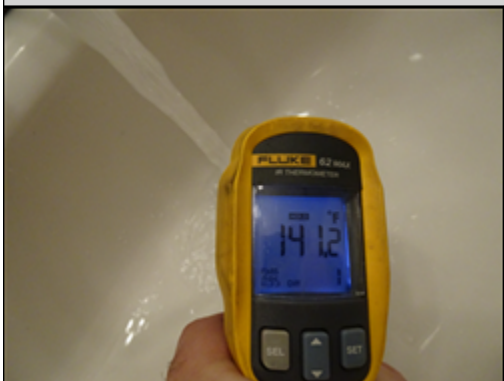
The hot water temperature for the home was noted to be too high. The recommended temperature to prevent personal injury and burns is 120 degrees F. The elevated temperature could indicate a malfunction or problems with the water heating unit. A licensed plumbing contractor should be consulted to evaluate the system to ensure that the water heating unit is operating correctly and within a safe temperature range.

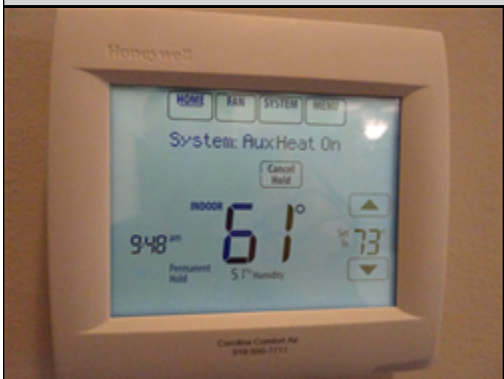
The heat pump was not operating properly at the time of the inspection. The auxiliary heat designed to assist the unit in extreme temperatures did not function in auxiliary or emergency mode. A HVAC contractor should be consulted for a complete evaluation and to make necessary repairs to ensure safe, reliable, and proper operation of the HVAC system.

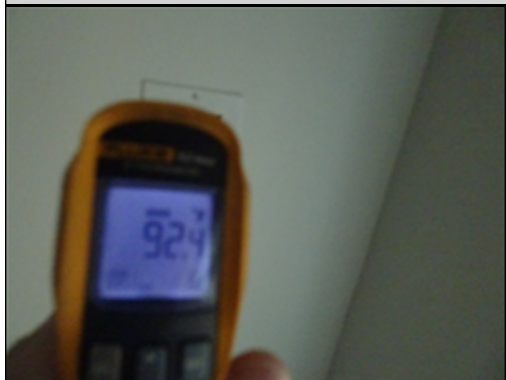
Typically, this temperature is 110 degrees or more.

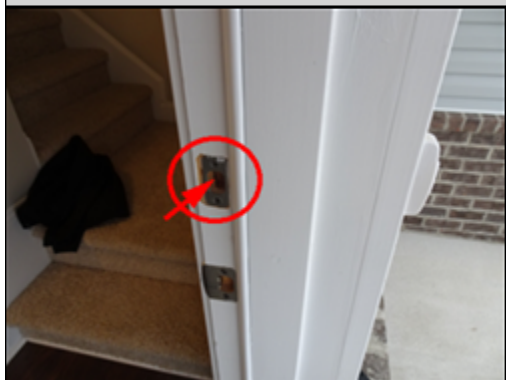
The hole is too short and the screws used for the deadbolt are light weight, not heavy duty. Also, the off centered heavy duty strike plate directs the screw more toward middle of the stud. The proper off centered strike plate should be installed so that the screws enter the proper portion of the stud. The trim will easily break if an intruder were to force their entry. These should be replaced with off centered heavy duty plate and proper screws that reach into the stud by a licensed general contractor.

Note - some builders purchase locks without this security feature. The repair is still recommended.

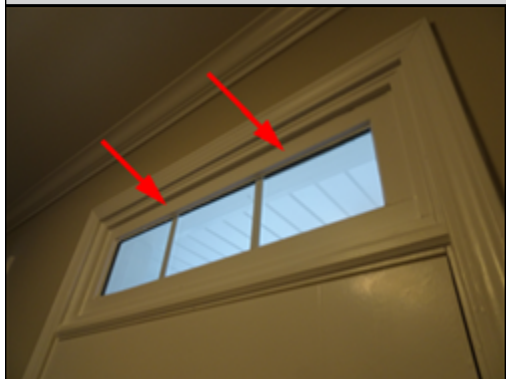
Area like this where paint has dripped significantly is not part of the home inspection. The buyer should review all areas adding blue tape as needed to guide repairs.

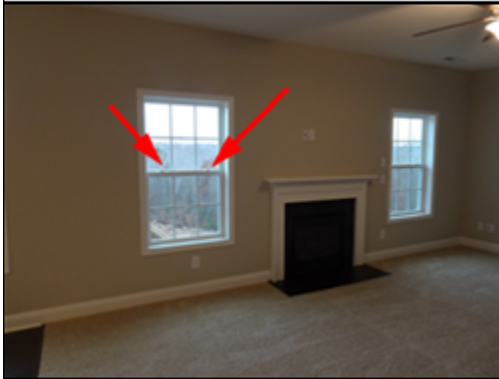
The window needs repair to ensure proper operation. The window did not properly latch. All windows should be evaluated as repairs are made. A licensed general contractor should be consulted to review the installation and repair as needed to ensure safe and secure operation.

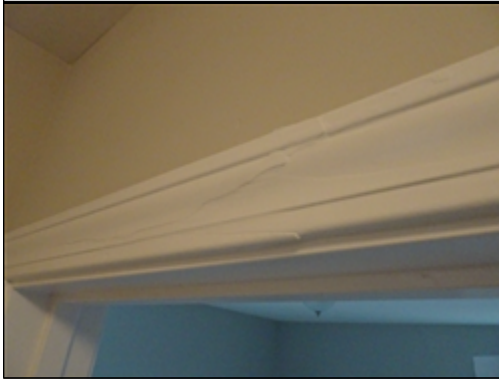
The trim above the door appears to have been broken and then installed.

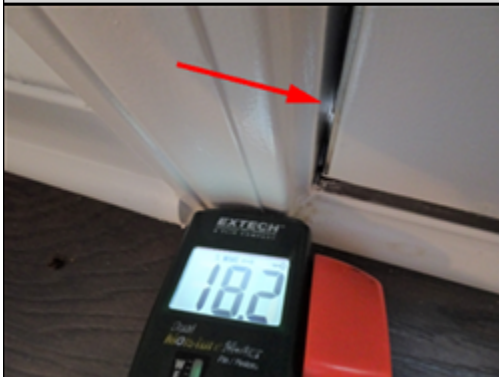
This water stain by the rear door was found to be moist/wet at the time of inspection as measured using a moisture meter tool. Further investigation is needed by a licensed general contractor to determine the extent of the damage. Hidden damage is likely.

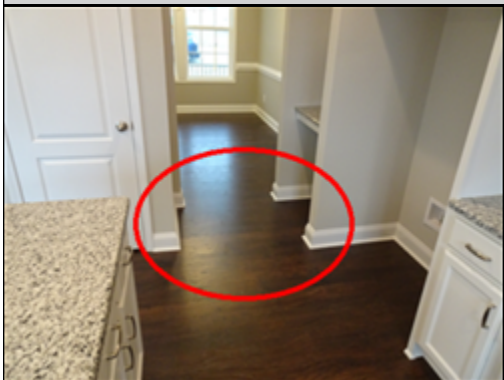
There is a creak in the floor. The sheeting that attaches to the floor joist is loose. A licensed general contractor should be consulted for the repair to the floor.

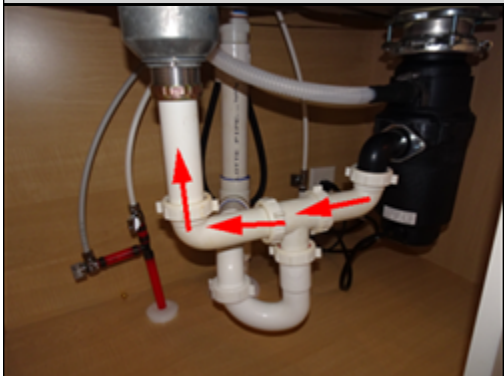
This design shoots water up through the other sink when the disposal runs and then down the drain. A general repair specialist or licensed general contractor should be consulted for evaluation and repair.

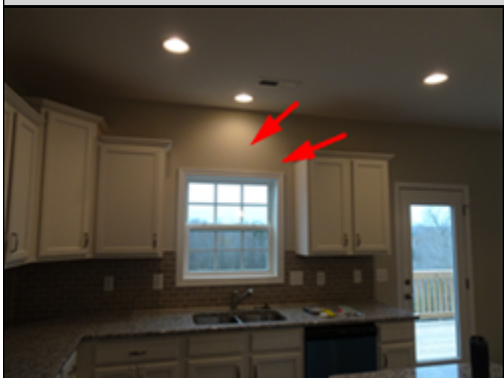
Nail pops were found which mean that the drywall was not properly fastened to the wall. The drywall moves when pressed on. This is not cosmetic. This is incorrect installation of the drywall. This applies to multiple areas of the home. A general repair specialist or licensed general contractor should be consulted for evaluation and repair.

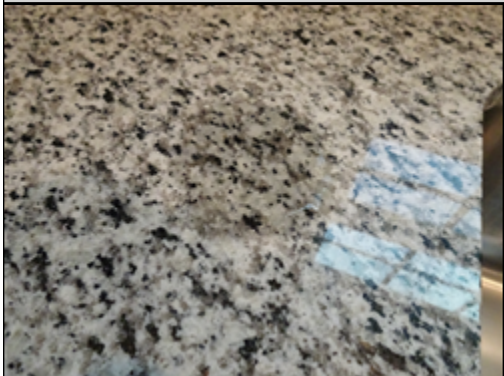
The granite absorbs water which means that the sealing process is not keeping water out of the granite. This means that the granite may become stained if a substance like wine is spilt on the counter top. All of the counter tops in the home should be evaluated and repaired as needed by a general contractor to ensure that all systems are functioning as intended. The contractor should consult specialist in each trade as needed.

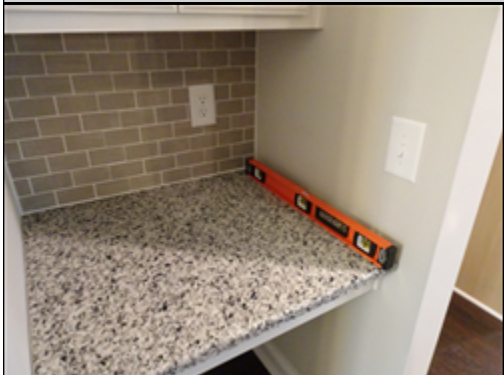
This counter is significantly slanted downward. All systems listed should be evaluated and repaired as needed by a general contractor to ensure that all systems are functioning as intended. The contractor should consult specialist in each trade as needed.

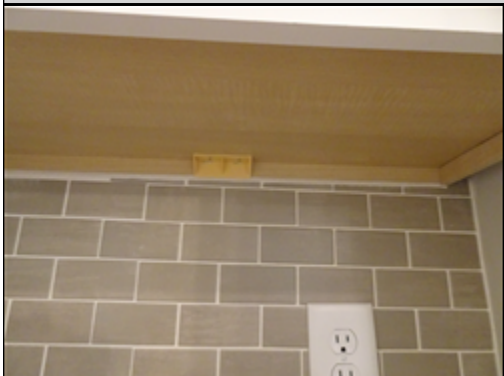
This has also effected the tile installation which will be more evident after the counter is repaired.

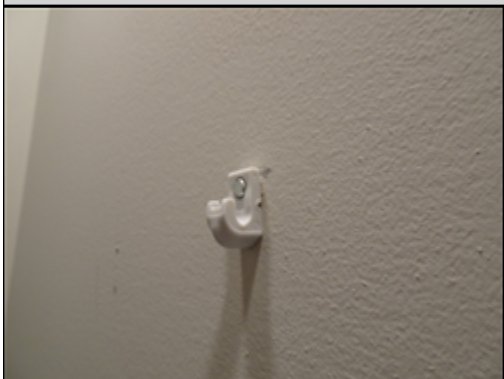
The mirror for the bathroom has been mounted with a fastener that is not typical and is more likely to fail causing the mirror to fall. Broken glass can cause serious injuries. A licensed general contractor should be consulted for a complete evaluation to determine the significance of this concern and make necessary repairs.

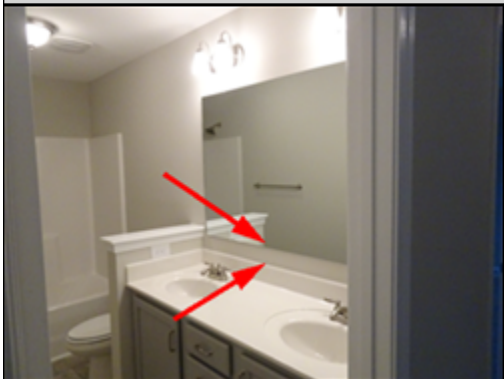
The mirrors are mounted higher than what is common. This should be compared to the model and relocated if needed.

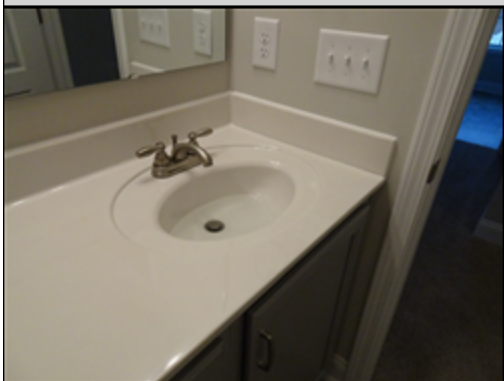
The sink drain was noted to drain slow when filled above halfway. This could be a clogged trap or a more significant plumbing issue. A licensed plumber should be consulted for repair.

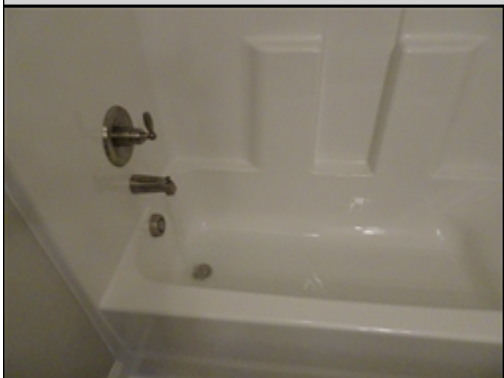
The tub/shower drain is slightly slow and does not keep up with the flow of the shower. This could be a simple clog or a more significant repair needed to the drain system. A licensed plumber should be consulted to evaluate and repair the drain system.

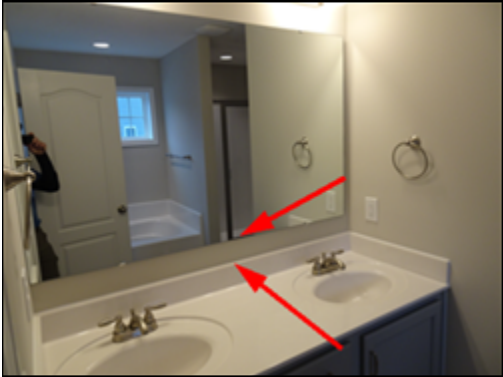
The mirrors are mounted higher than what is common. This should be compared to the model and relocated if needed.

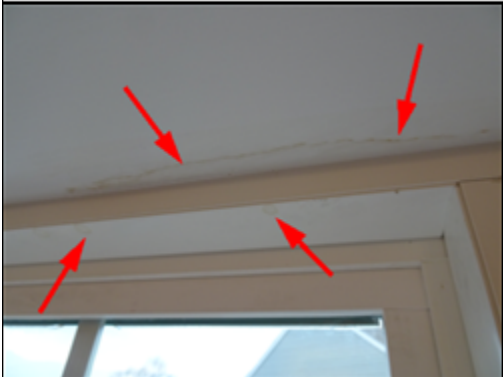
A stain was found here on the trim around the window which measured as dry with a moisture meter. This could reoccur at anytime. A licensed general contractor should be consulted for the evaluation and repair.

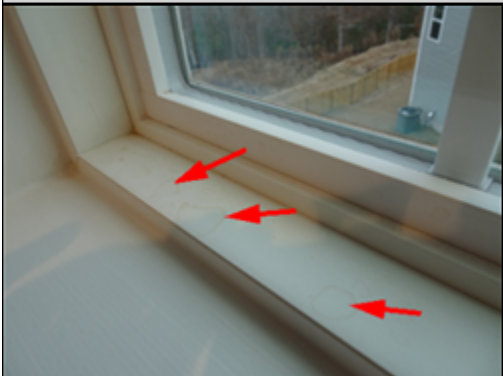
More water marks on the window.

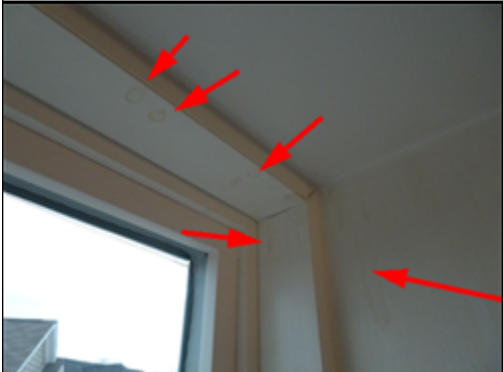
More water marks around the window.

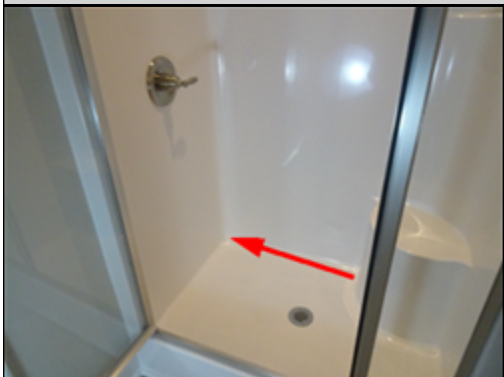
The fiberglass/acrylic tub has a break in the surface that exposes the structural matt. The chip could allow water to penetrate under the surface and possibility result in leaks. A licensed general contractor should be consulted to determine if the tub surface can be repaired or if replacement is needed.

Note - the damage came from the outside the shower, the source of the damage must be repaired or the crack will return.

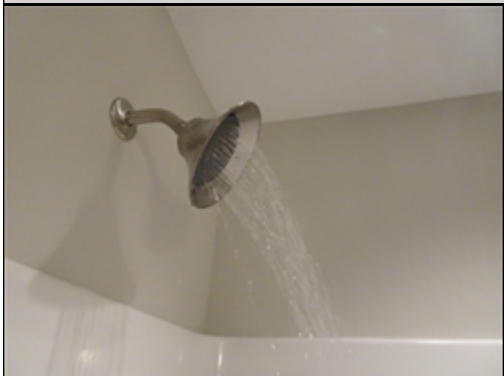
The water pressure is low at this fixture. This can be from something as simple as a clogged aerator or shower head. It could also be a faulty faucet or a larger plumbing issue. A licensed plumber or general contractor should be consulted for the repair.

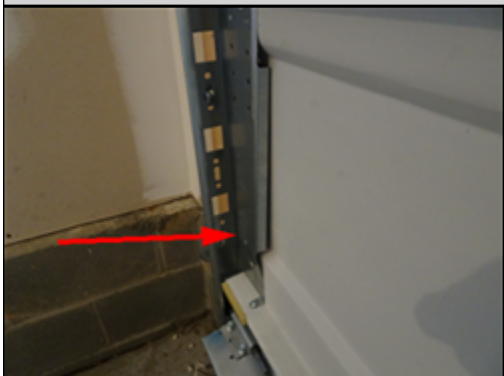
The bracket on the second panel is bent outward. This will likely effect the door function in the future. All systems listed should be evaluated and repaired as needed by a general contractor to ensure that all systems are functioning as intended.

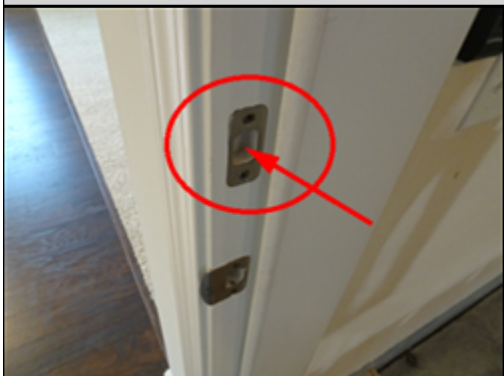
See Foyer regarding the deadbolts.

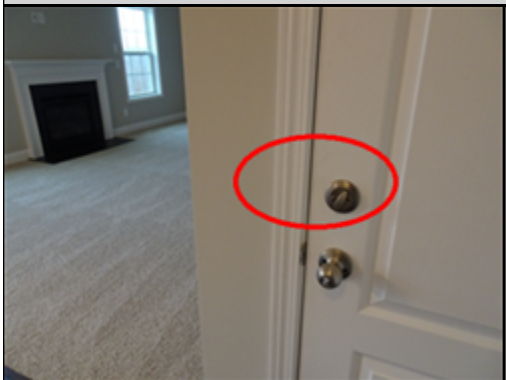
The door lock assembly is not aligned with the striker in the jamb area. The lock could not be engaged to secure the door easily. The door/lock needs repair/replacement to ensure that the door closes securely and operates properly. A general repair specialist or licensed general contractor should be consulted for evaluation and repair.

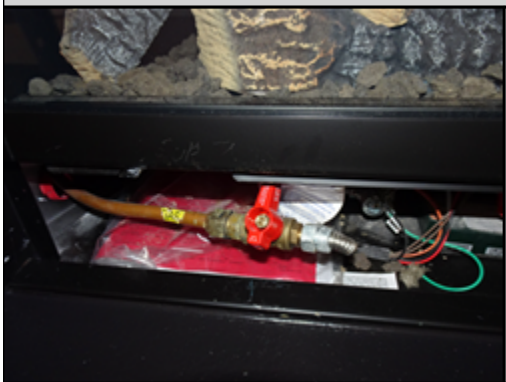
The gas log unit was visually inspected but not operated because the gas was off. The unit should be serviced and operated prior to closing to ensure safe and proper operation of the HVAC system.

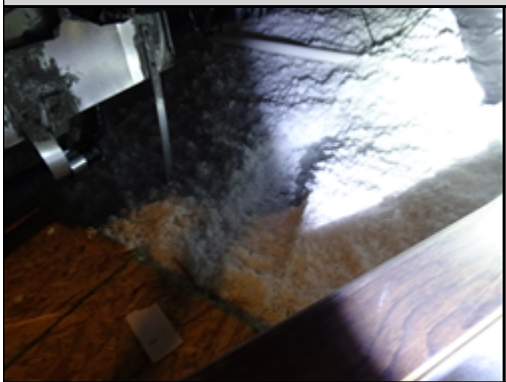
The insulation is compressed or displaced. The effectiveness of the insulation is reduced when displaced or compressed. Improper insulation installation could result in condensation, over heating of the building components, and inadequate conditioning of the living areas. A licensed general contractor should be consulted for repair/replacement.

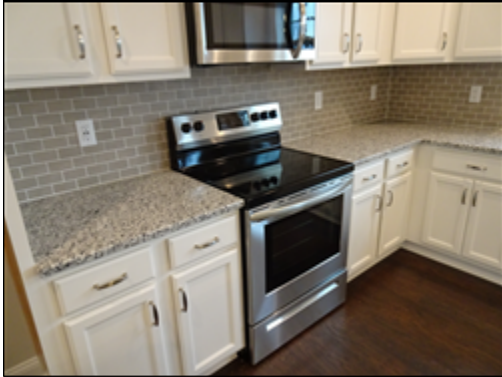
The oven had no power and was not tested. An appliance repair specialist should be consulted for further evaluation and repair to ensure safe and proper operation of the appliance.
