Property Inspection Report

Report Number: 10106

401 Buyme Lane
Observation, NC 27513

Date of Inspection: Thursday, February 13, 2020

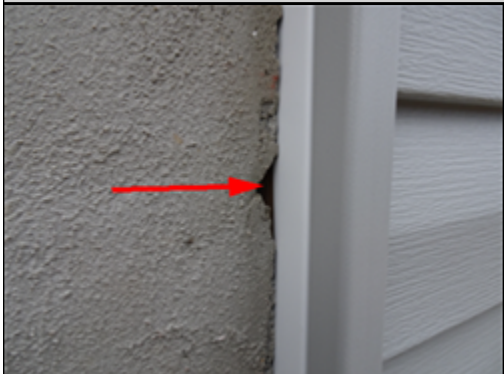
(B1 - 1.7) Main House

The siding is not covering the wall structure. This should be repaired or replaced by a general contractor to prevent damage from water entry into the wall. Future hidden damage is possible.

Additional Photograph: This is a photograph of the wall structure.
